Phase I Environmental Site Assessment

5 – 70 Archerhill Court, Aurora, Ontario

BRM-21000267-B0

February 26, 2021

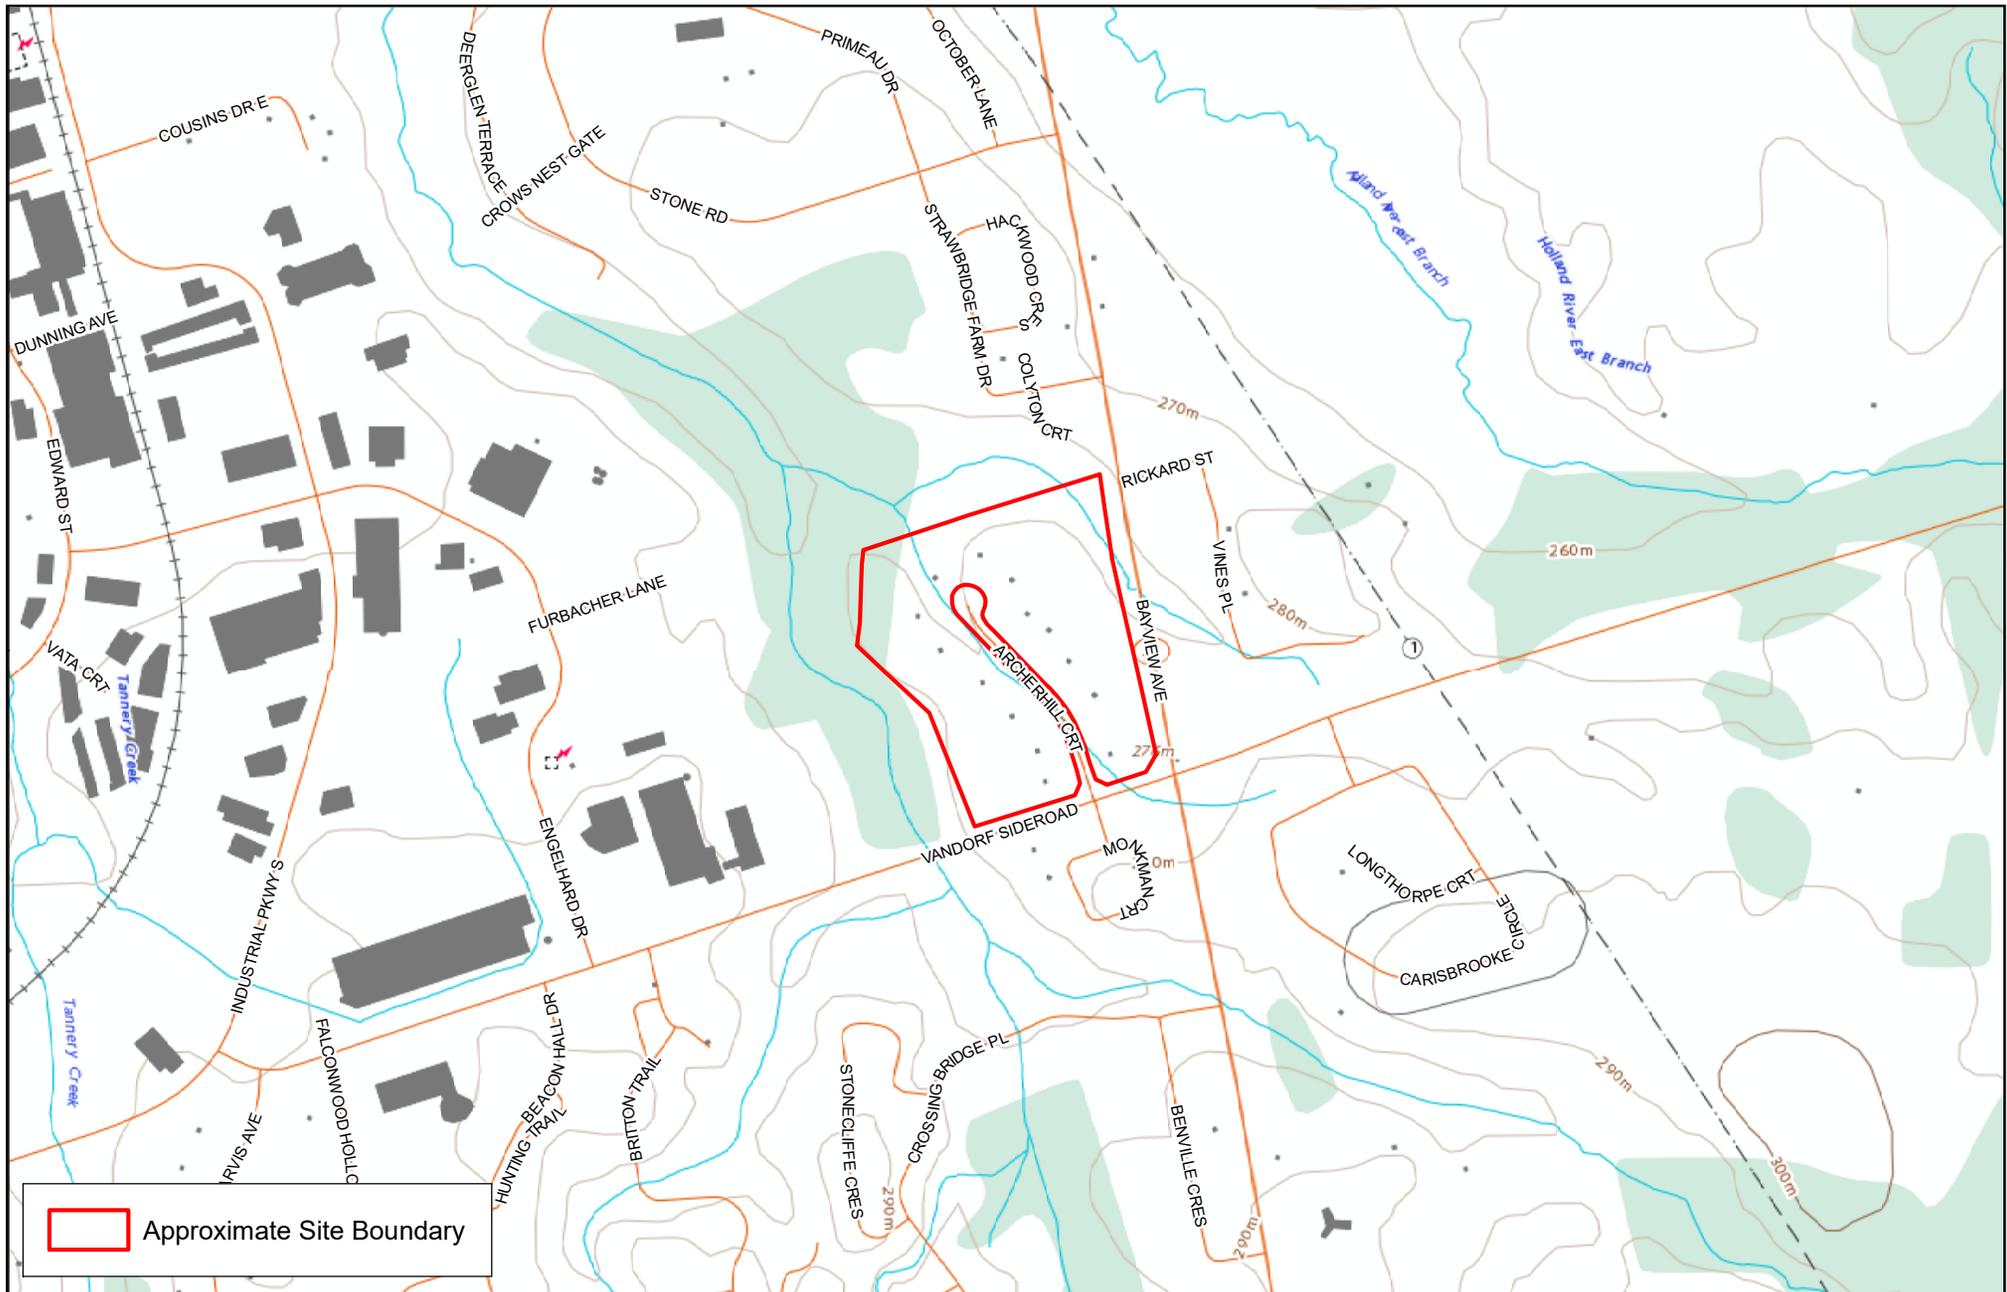
PROJECT No:	BRM-21000267-B0	OWN:	AC
SCALE:	AS NOTED	CHKD:	JS
DATE:	FEBRUARY 2021	FIG. No.:	1

SITE LOCATION PLAN
 Phase I Environmental Site Assessment
 5 - 70 Archerhill Court
 Aurora, Ontario

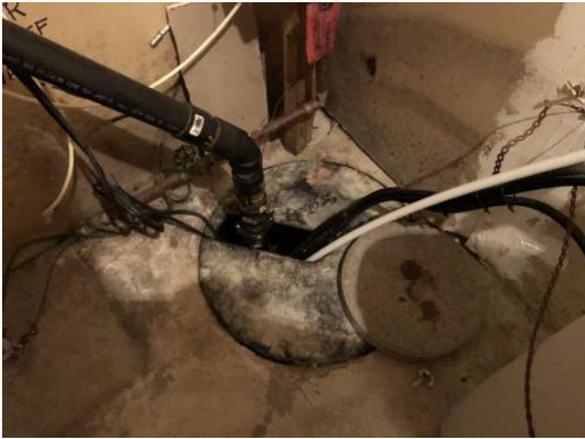
Photo 1: View of the typical sump pit and sump pump observed in all residential properties accessed on Site.

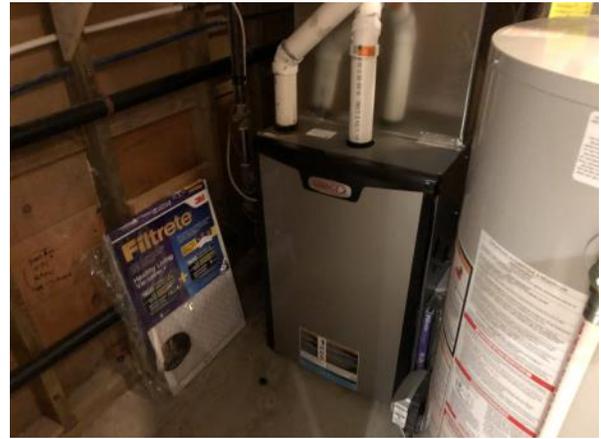
Each residential home was heated and cooled through a natural gas fired furnace and air-conditioning unit.

Photo 2: View of the typical natural gas fired furnace observed in all residential properties accessed on Site.

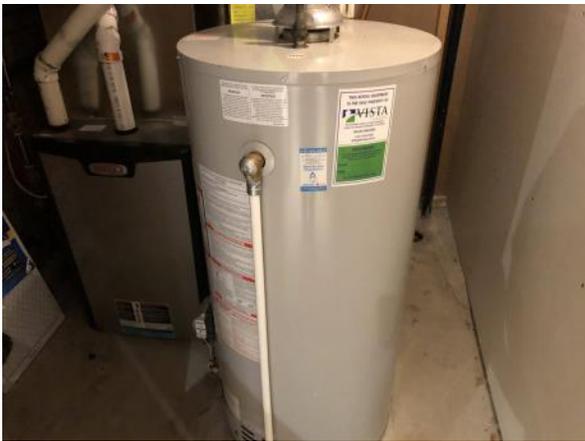
Photo 3: View of the typical hot water tank observed in all residential properties accessed on Site.

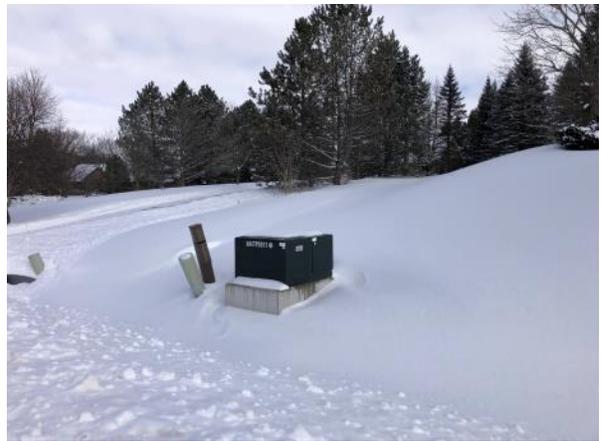
Four (4) pad-mounted transformers were observed on Site along Archerhill Court. No staining was observed on the concrete pad beneath the transformers and the concrete was in good condition.

Photo 4: View of one of four pad-mounted transformers observed on Site.
